Flood Control Project Maintenance
2019 Structure Summary Report
Overall Unit and Item Ratings

Lower San Joaquin Levee District

Ash Slough Drop Structure No. 1

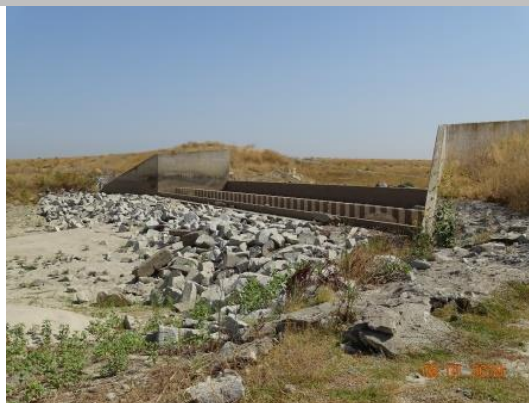
Photo 1 of 3 : ST_2019_NA0010_30_1_20190613_00001.jpg

Overview of structure looking upstream from left bank. (2018)

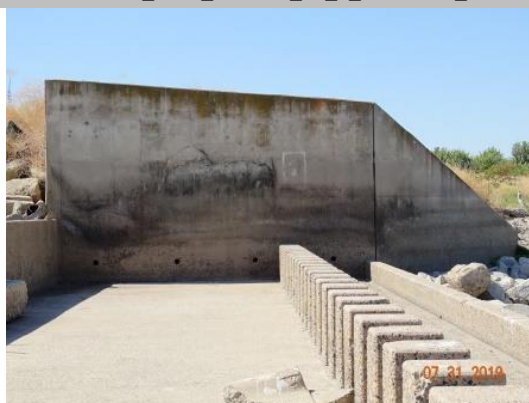
Photo 2 of 3 : ST_2019_NA0010_30_1_20190807_00009.jpg

View of the left wing wall. (2019)

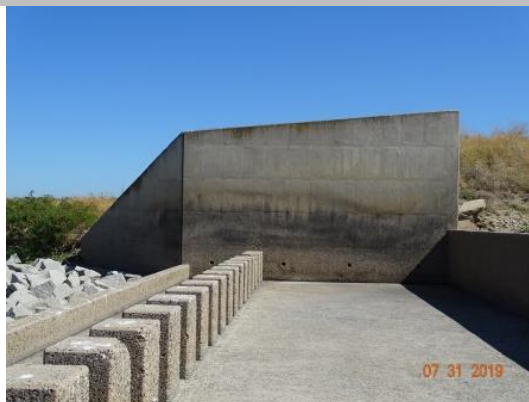
Photo 3 of 3 : ST_2019_NA0010_30_1_20190807_00010.jpg

View of the right wing wall. (2019)

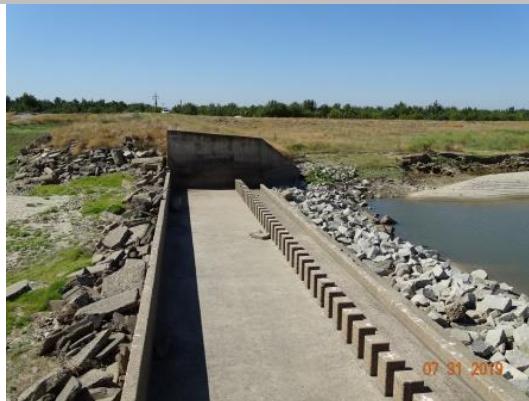
Photo 1 of 2 : ST_2019_NA0010_30_5_20190807_00011.jpg

LM Start	0.00	Rating **	A	Issue No.	5
LM End	0.00	Issue Type +	Ma	Location *	
Category	Structures & Concrete Lined Channels			GPS Latitude/Longitude	
				Start	End
Item	Revetments			36.975706 °	36.975706 °
				-120.374885 °	-120.374885 °
DWR ID	DWR_NA0010_30_t_2012_5				
Action/Comments					
Inspector Comments: Revetment appears to be properly maintained.

View of downstream revetment from right wing wall. (2019)

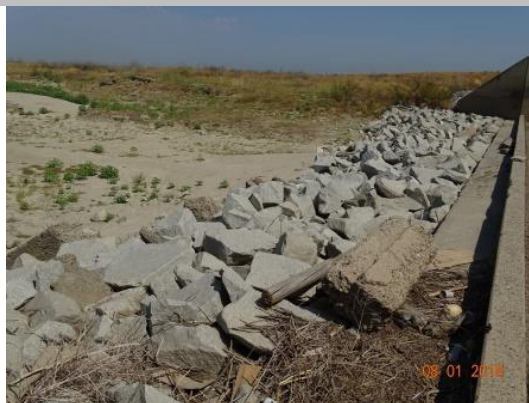
Photo 2 of 2 : ST_2019_NA0010_30_5_20190613_00003.jpg

View of downstream revetment. (2018)

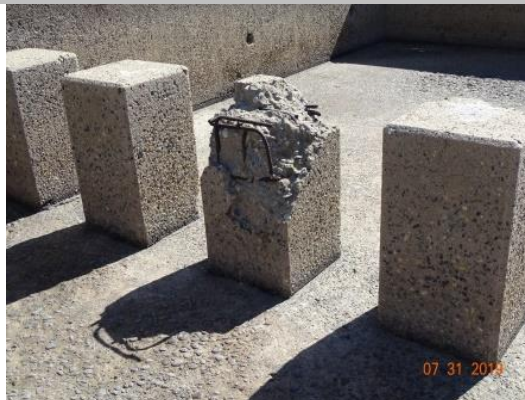
Photo 1 of 1 : ST_2019_NA0010_30_15_20190807_00012.jpg

LM Start	0.00	Rating **	M	Issue No.	15	
LM End	0.00	Issue Type +	Ma	Location *		
Category	Structures & Concrete Lined Channels			GPS Latitude/Longitude		
				Start		End
Item	Concrete Surfaces			36.975706 °		36.975706 °
				-120.374885 °		-120.374885 °
DWR ID	DWR_NA0010_30_t_2012_15					
Action/Comments						
Inspector Comments: Damage to dissipator near right wing wall.

Dissipator near right wing wall is damaged. (2019)

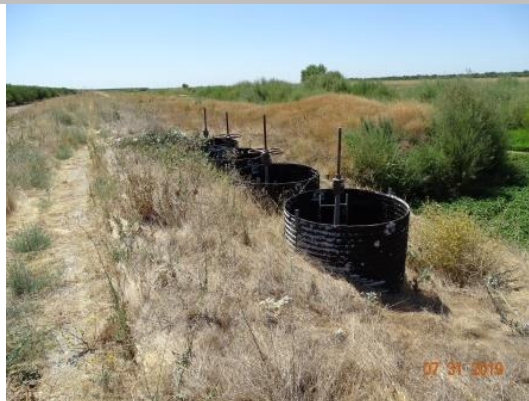
Photo 1 of 3 : ST_2019_NA0010_39_1_20190807_00013.jpg

View of control gates looking south. (2019)

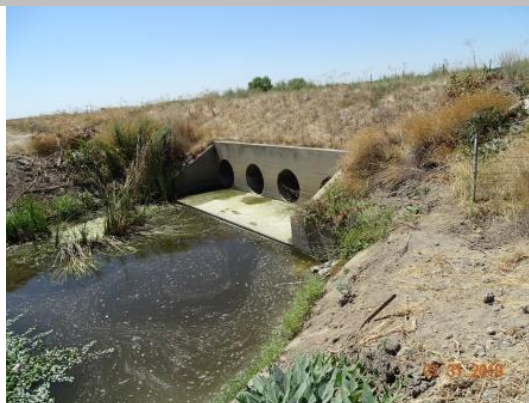
Photo 2 of 3 : ST_2019_NA0010_39_1_20190807_00012.jpg

View of inlet side of the structure. (2019)

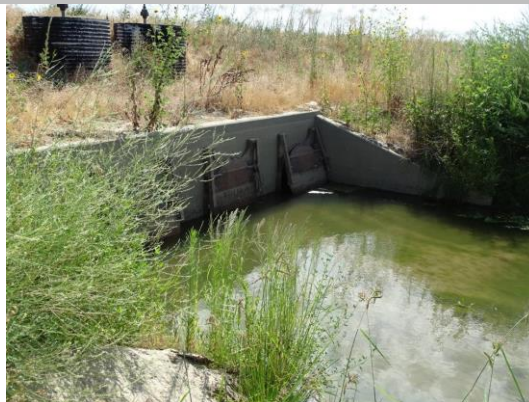
Photo 3 of 3 : ST_2019_NA0010_39_1_20190613_00003.jpg

View of outlet side of structure looking southeast (Summer 2017)

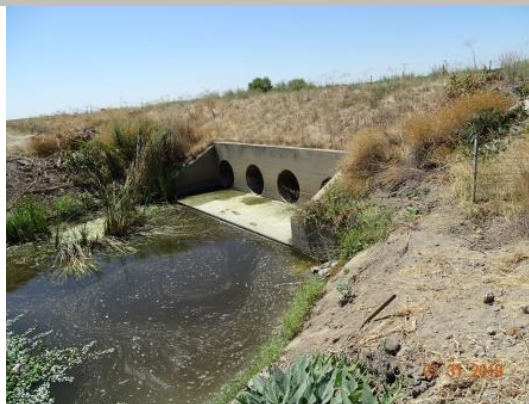
Photo 1 of 2 : ST_2019_NA0010_39_7_20190807_00015.jpg

LM Start	0.00	Rating **	A	Issue No.	7
LM End	0.00	Issue Type +	Ma	Location *	
Category	Structures & Concrete Lined Channels	GPS Latitude/Longitude			
		Start		End	
Item	Culverts: Inlets / Outlets	36.975418 °		36.975418 °	
		-120.359578 °		-120.359578 °	
DWR ID	DWR_NA0010_39_t_2012_7				
Action/Comments					
Inspector Comments: Culverts are clear of obstructions. Wood planks were used to prop open the flap gates (see issue 6).

View of inlet side of structure. (2019)

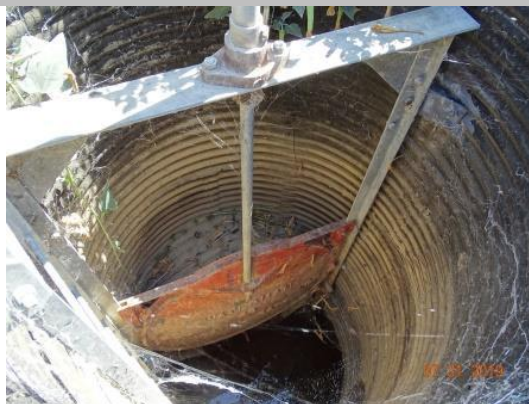
Photo 1 of 1 : ST_2019_NA0010_39_12_20190807_00018.jpg

LM Start	0.00	Rating **	A	Issue No.	12
LM End	0.00	Issue Type +	Ma	Location *	
Category	Structures & Concrete Lined Channels	GPS Latitude/Longitude			
		Start		End	
Item	Sluice/Slide Gates	36.975418 °		36.975418 °	
		-120.359578 °		-120.359578 °	
DWR ID	DWR_NA0010_39_t_2012_12				
Action/Comments					
Inspector Comments: Slide gates appear to be in good condition.

Typical view of slide gate. (2019)

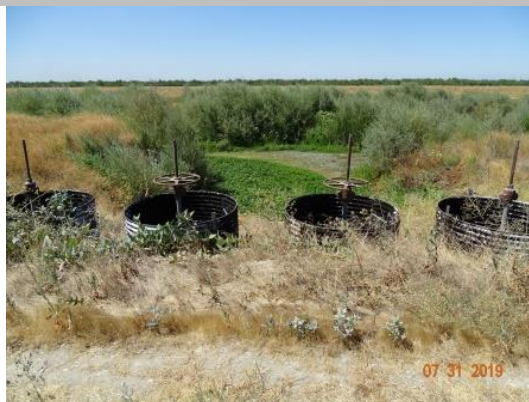
Photo 1 of 2 : ST_2019_NA0010_39_14_20190807_00020.jpg

LM Start	0.00	Rating **	M	Issue No.	14
LM End	0.00	Issue Type +	Ma	Location *	
Category	Structures & Concrete Lined Channels			GPS Latitude/Longitude	
				Start	End
Item	Manual Gate Operators			36.975418 °	36.975418 °
				-120.359578 °	-120.359578 °
DWR ID	DWR_NA0010_39_t_2012_14				
Action/Comments					
Inspector Comments: Missing wheel on two of four screw gates. One wheel handle is broken. Wheel handles could not be operated. Manual operator components should be greased and maintained.

View of slide gate manual operators. (2019)

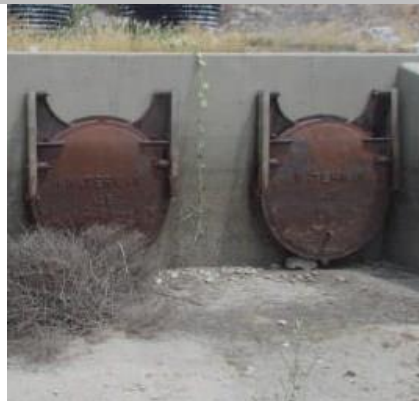
Photo 1 of 1 : ST_2019_NA0010_39_21_20190613_00011.jpg

LM Start	0.00	Rating **	A	Issue No.	21
LM End	0.00	Issue Type +	Ma	Location *	
Category	Structures & Concrete Lined Channels			GPS Latitude/Longitude	
				Start	End
Item	Other Metallic Items			36.975418 °	36.975418 °
				-120.359578 °	-120.359578 °
DWR ID	DWR_NA0010_39_t_2017_21				
Action/Comments					
Inspector Comments: Minor corrosion seen on flap gates.

Looking at flap gates on downstream side of structure. (Summer 2016)

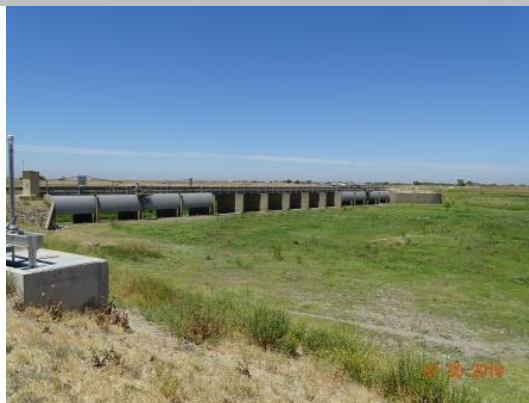
Photo 1 of 4 : ST_2019_NA0010_44_1_20190806_00015.jpg

Overview of upstream side of structure. (2019)

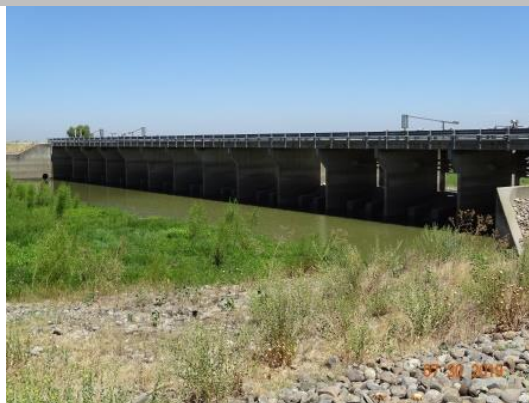
Photo 2 of 4 : ST_2019_NA0010_44_1_20190806_00016.jpg

Overview of downstream side of structure. (2019)

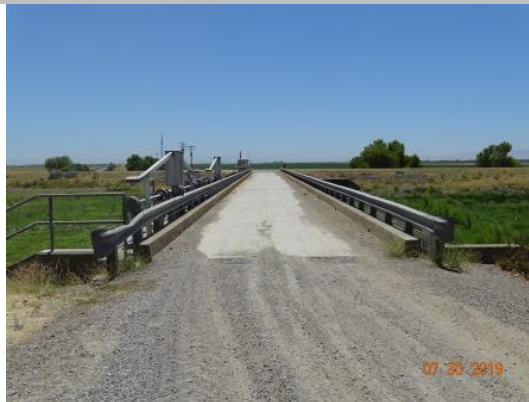
Photo 3 of 4 : ST_2019_NA0010_44_1_20190806_00020.jpg

View across the top of structure. (2019)

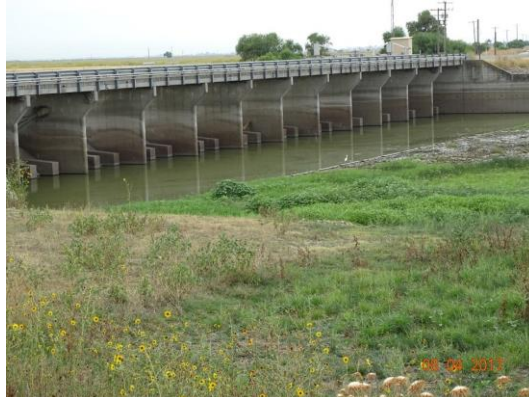
Photo 4 of 4 : ST_2019_NA0010_44_1_20190613_00004.jpg

Looking southeast at the downstream side of the structure. (2017)

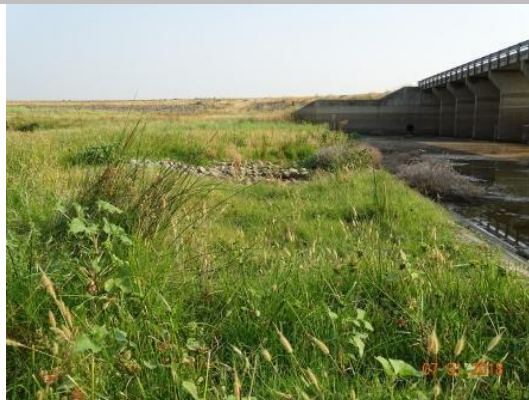
Photo 1 of 2 : ST_2019_NA0010_44_5_20190613_00005.jpg

LM Start	0.00	Rating **	A	Issue No.	5	
LM End	0.00	Issue Type +	Ma	Location *		
Category	Structures & Concrete Lined Channels			GPS Latitude/Longitude		
				Start		End
Item	Revetments			37.201538 °		37.201538 °
				-120.694813 °		-120.694813 °
DWR ID	DWR_NA0010_44_t_2012_5					
Action/Comments						
Inspector Comments: Revetments appear to be in proper condition. Some minor erosion on the outlet side of the structure but riprap is still intact in the area.

Revetment erosion spot downstream of structure. (2018)

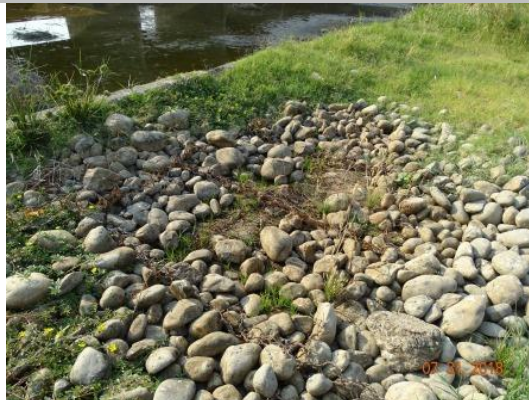
Photo 2 of 2 : ST_2019_NA0010_44_5_20190613_00006.jpg

Close up view of erosion spot. (2018)

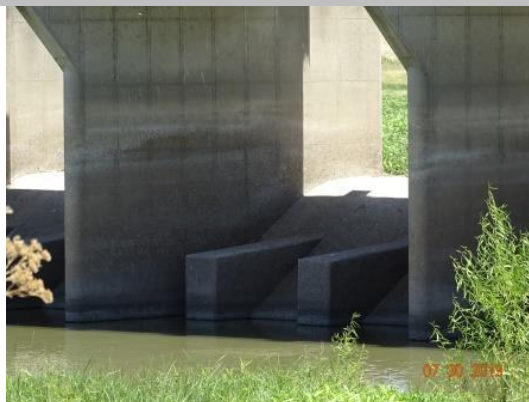
Photo 1 of 1 : ST_2019_NA0010_44_7_20190806_00021.jpg

LM Start	0.00	Rating **	A	Issue No.	7
LM End	0.00	Issue Type +	Ma	Location *	
Category	Structures & Concrete Lined Channels			GPS Latitude/Longitude	
				Start	End
Item	Culverts: Inlets / Outlets			37.201538 °	37.201538 °
				-120.694813 °	-120.694813 °
DWR ID	DWR_NA0010_44_t_2012_7				
Action/Comments					
Inspector Comments: No debris blocking culverts.

Typical view of outlets. (2019)

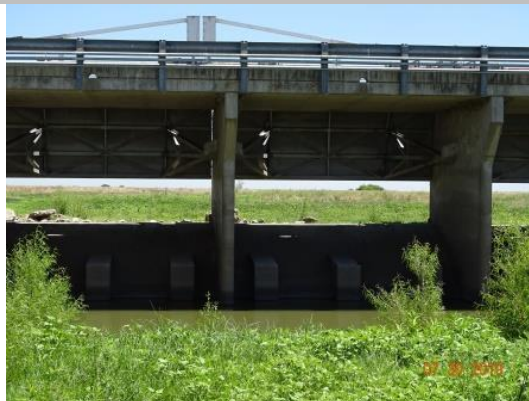
Photo 1 of 1 : ST_2019_NA0010_44_12_20190806_00022.jpg

LM Start	0.00	Rating **	A	Issue No.	12
LM End	0.00	Issue Type +	Ma	Location *	
Category	Structures & Concrete Lined Channels	GPS Latitude/Longitude			
		Start		End	
Item	Sluice/Slide Gates	37.201538 °		37.201538 °	
		-120.694813 °		-120.694813 °	
DWR ID	DWR_NA0010_44_t_2012_12				
Action/Comments					
Inspector Comments: No visible damage, sediment or obstructions identified.

View of the radial gates. (2019)

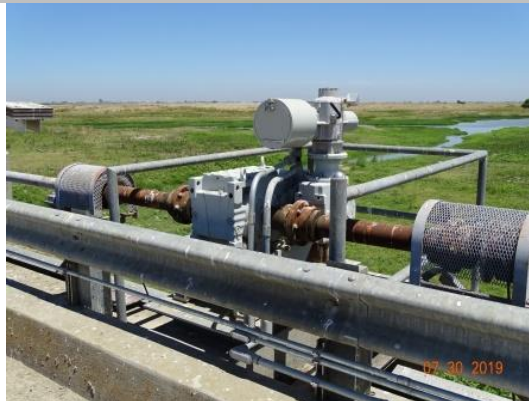
Photo 1 of 4 : ST_2019_NA0010_44_13_20190806_00023.jpg

Typical view of electrical gates on upstream side of structure. (2019)

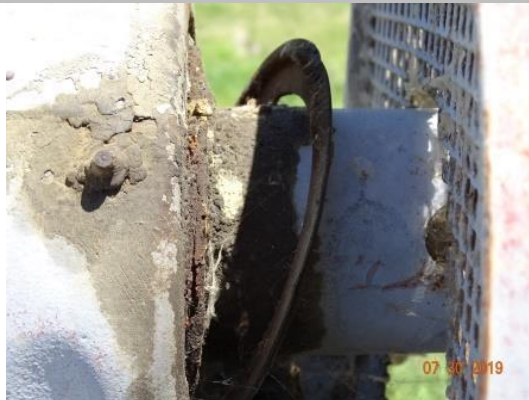
Photo 2 of 4 : ST_2019_NA0010_44_13_20190806_00025.jpg

LM Start	0.00	Rating **	A	Issue No.	13
LM End	0.00	Issue Type +	Ma	Location *	
Category	Structures & Concrete Lined Channels	GPS Latitude/Longitude			
		Start		End	
Item	Electric Gate Operators	37.201538 °		37.201538 °	
		-120.694813 °		-120.694813 °	
DWR ID	DWR_NA0010_44_t_2012_13				
Action/Comments					
Inspector Comments: Electrical gates appear to be in proper working condition. Some of the plates on ball bearing encasements have been displaced.

Bearing plates dislodged from bearing encasement. (2019)

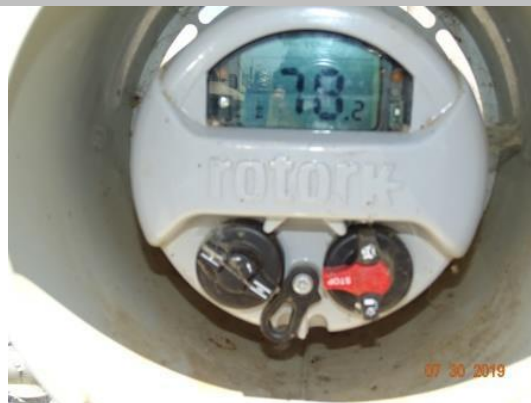
Photo 3 of 4 : ST_2019_NA0010_44_13_20190806_00026.jpg

View of electrical gate controls. (2019)

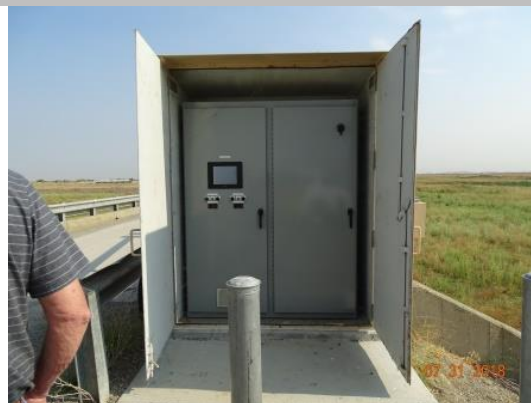
Photo 4 of 4 : ST_2019_NA0010_44_13_20190613_00011.jpg

View of control panel. (2018)

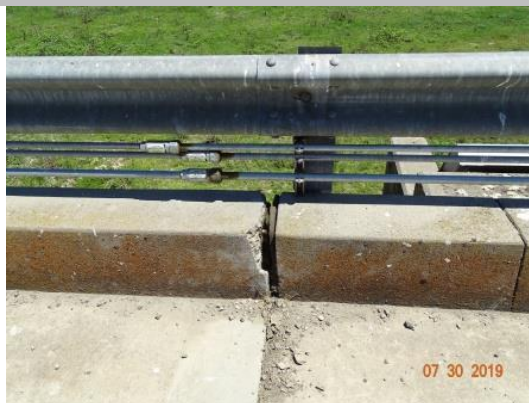
Photo 1 of 2 : ST_2019_NA0010_44_15_20190806_00027.jpg

LM Start	0.00	Rating **	A	Issue No.	15
LM End	0.00	Issue Type +	Ma	Location *	
Category	Structures & Concrete Lined Channels			GPS Latitude/Longitude	
				Start	End
Item	Concrete Surfaces			37.201538 °	37.201538 °
				-120.694813 °	-120.694813 °
DWR ID	DWR_NA0010_44_t_2012_15				
Action/Comments					
Inspector Comments: Exposed rebar at expansion joint on upstream side of structure.

Exposed rebar at expansion joint on upstream side of structure. (2019)

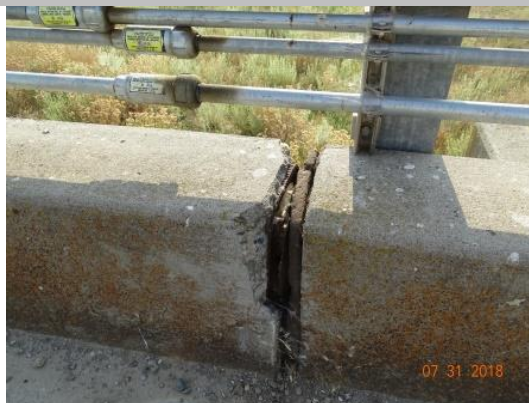
Photo 2 of 2 : ST_2019_NA0010_44_15_20190613_00013.jpg

Close up of exposed rebar. (2018)

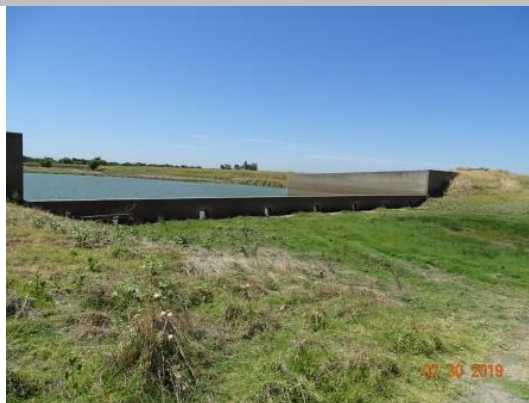
Photo 1 of 4 : ST_2019_NA0010_31_1_20190806_00009.jpg

View of downstream side of structure. (2019)

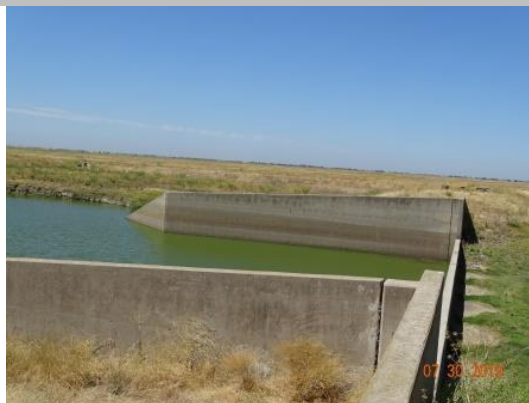
Photo 2 of 4 : ST_2019_NA0010_31_1_20190806_00008.jpg

View of right wing wall. (2019)

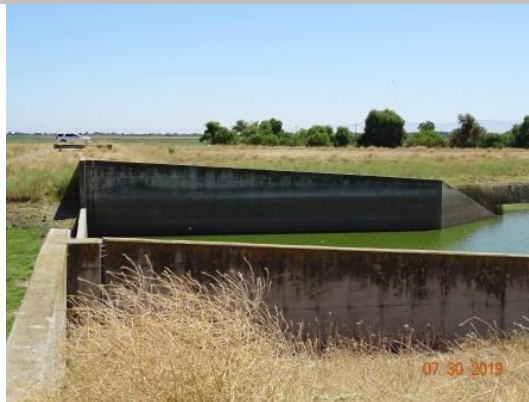
Photo 3 of 4 : ST_2019_NA0010_31_1_20190806_00012.jpg

View of left wing wall. (2019)

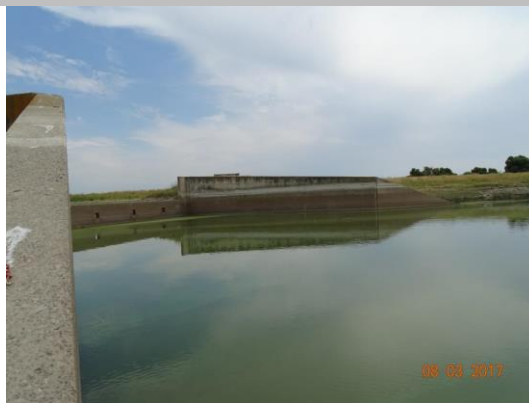
Photo 4 of 4 : ST_2019_NA0010_31_1_20190613_00004.jpg

Looking southeast at the downstream side of the structure. (2017)

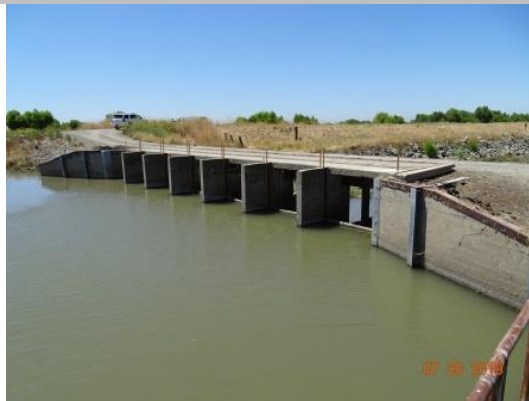
Photo 1 of 3 : ST_2019_NA0010_49_1_20190802_00024.jpg

LM Start	0.00	Rating **	N	Issue No.	1
LM End	0.00	Issue Type +	Ma	Location *	
Category	Structures & Concrete Lined Channels			GPS Latitude/Longitude	
				Start	End
Item	Photo Documentation			37.219637 °	37.219637 °
				-120.698018 °	-120.698018 °
DWR ID	DWR_NA0010_49_t_2018_1				
Action/Comments					
Inspector Comments: The control structure has structural defects at multiple locations. The LMA appears to have stabilized the structure with external steel reinforcements (see photos throughout).

View of inlet side of the structure. (2019)

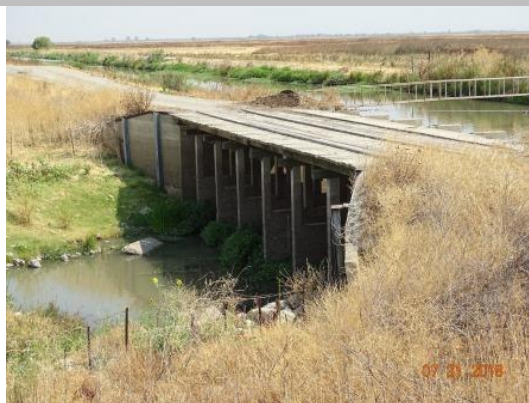
Photo 2 of 3 : ST_2019_NA0010_49_1_20190613_00002.jpg

View of outlet side of the structure. (2018)

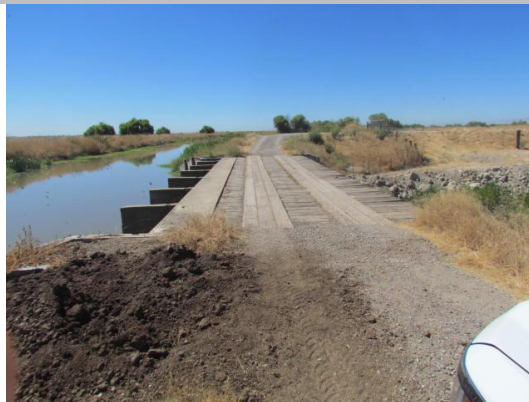
Photo 3 of 3 : ST_2019_NA0010_49_1_20190613_00003.jpg

Looking at (overview) top of structure. (2016)

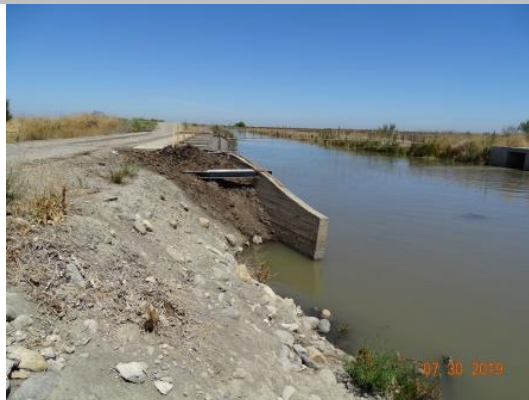
Photo 1 of 3 : ST_2019_NA0010_49_4_20190802_00026.jpg

LM Start	0.00	Rating **	M	Issue No.	4
LM End	0.00	Issue Type +	Ma	Location *	
Category	Structures & Concrete Lined Channels			GPS Latitude/Longitude	
				Start	End
Item	Erosion / Bank Caving			37.219637 °	37.219637 °
				-120.698018 °	-120.698018 °
DWR ID	DWR_NA0010_49_t_2012_4				
Action/Comments					
Inspector Comments: LMA brought in fill material to backfill holes and erosion sites. Minor erosion around the left inlet headwall.

View of left headwall, possible erosion on landside of wall. (2019)

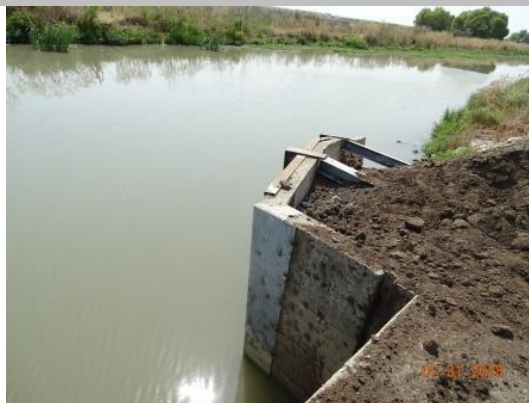
Photo 2 of 3 : ST_2019_NA0010_49_4_20190613_00004.jpg

LM Start	0.00	Rating **	M	Issue No.	4 (cont)	
LM End	0.00	Issue Type +	Ma	Location *		
Category	Structures & Concrete Lined Channels			GPS Latitude/Longitude		
				Start	End	
Item	Erosion / Bank Caving			37.219637 °	37.219637 °	
				-120.698018 °	-120.698018 °	
DWR ID	DWR_NA0010_49_t_2012_4					
Action/Comments						
Inspector Comments: LMA brought in fill material to backfill holes and erosion sites. Minor erosion around the left inlet headwall.

Looking at braces on left headwall. (2018)

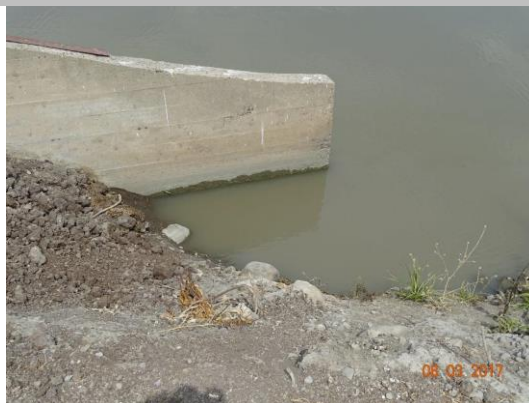
Photo 3 of 3 : ST_2019_NA0010_49_4_20190613_00005.jpg

Looking at the left headwall, possible erosion around the landside of the structure. (2017)

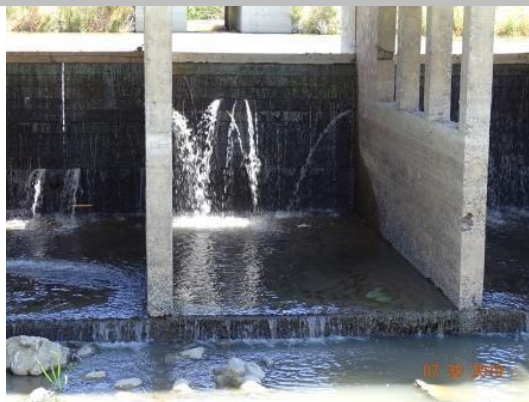
Photo 1 of 1 : ST_2019_NA0010_49_7_20190805_00032.jpg

LM Start	0.00	Rating **	A	Issue No.	7
LM End	0.00	Issue Type +	Ma	Location *	
Category	Structures & Concrete Lined Channels			GPS Latitude/Longitude	
				Start	End
Item	Culverts: Inlets / Outlets			37.219637 °	37.219637 °
				-120.698018 °	-120.698018 °
DWR ID	DWR_NA0010_49_t_2012_7				
Action/Comments					
Inspector Comments: No visible debris blocking the culverts.

View of outlet side of culvert. (2019)

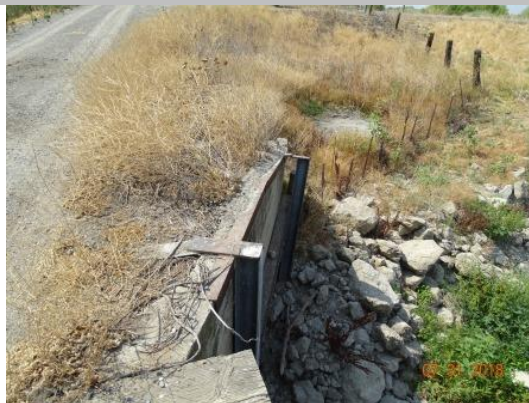
Photo 1 of 6 : ST_2019_NA0010_49_16_20190613_00015.jpg

LM Start	0.00	Rating **	M	Issue No.	16
LM End	0.00	Issue Type +	Ma	Location *	
Category	Structures & Concrete Lined Channels	GPS Latitude/Longitude			
		Start	End		
Item	Concrete Tilting / Settlement	37.219637 °		37.219637 °	
		-120.698018 °		-120.698018 °	
DWR ID	DWR_NA0010_49_t_2012_16				
Action/Comments					
Inspector Comments: Concrete tilting/settlement on upstream and downstream left wing walls has been stabilized by the LMA. Tilting is still visible but installed braces appear to be stabilizing the wingwalls.

Looking at brace on left wing wall on downstream side of structure. (2018)

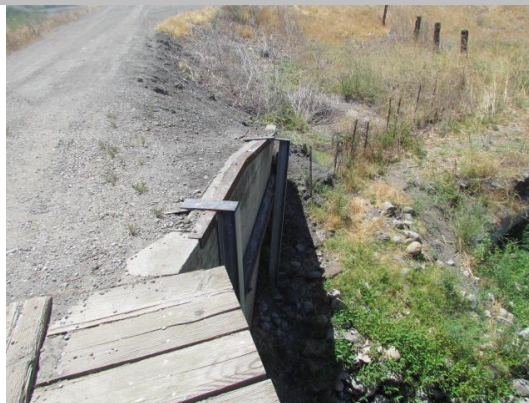
Photo 2 of 6 : ST_2019_NA0010_49_16_20190613_00016.jpg

Looking at brace on left wing wall on downstream side of structure. Summer 2012

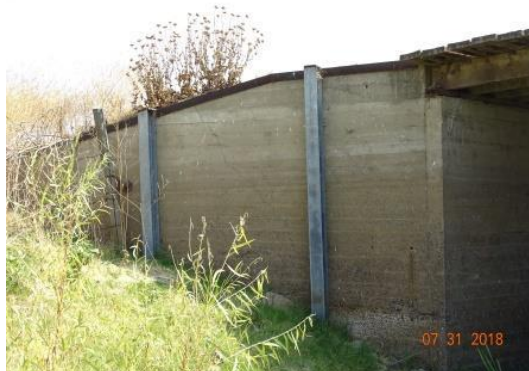
Photo 3 of 6 : ST_2019_NA0010_49_16_20190613_00017.jpg

LM Start	0.00	Rating **	M	Issue No.	16 (cont)	
LM End	0.00	Issue Type +	Ma	Location *		
Category	Structures & Concrete Lined Channels			GPS Latitude/Longitude		
				Start	End	
Item	Concrete Tilting / Settlement			37.219637 °	37.219637 °	
				-120.698018 °	-120.698018 °	
DWR ID	DWR_NA0010_49_t_2012_16					
Action/Comments						
Inspector Comments: Concrete tilting/settlement on upstream and downstream left wing walls has been stabilized by the LMA. Tilting is still visible but installed braces appear to be stabilizing the wingwalls.

Looking at braces on downstream right wing wall. (2018)

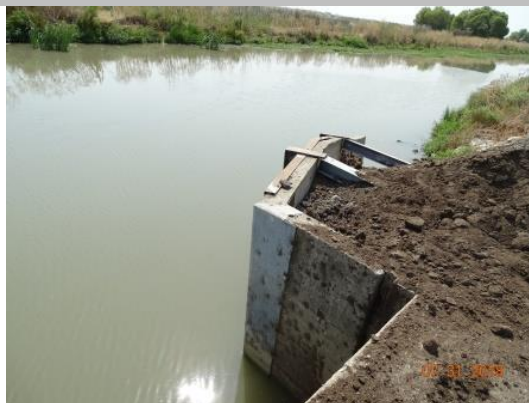
Photo 4 of 6 : ST_2019_NA0010_49_16_20190613_00018.jpg

Looking at upstream left wing wall. (2018)

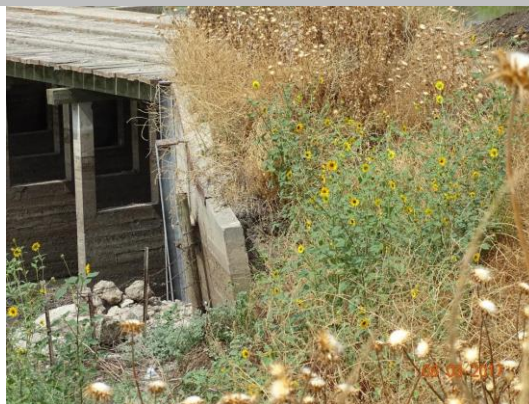
Photo 5 of 6 : ST_2019_NA0010_49_16_20190613_00019.jpg

Left wingwall tilting with braces in place. (2017)

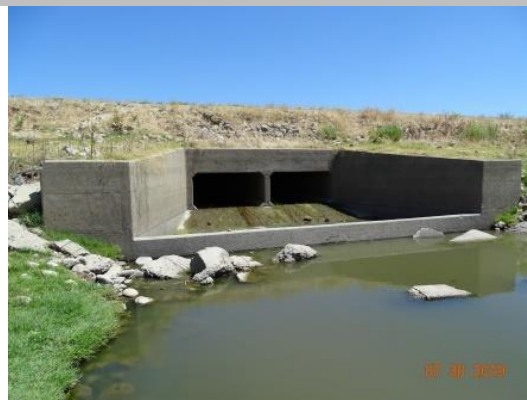
Photo 1 of 1 : ST_2019_NA0010_50_7_20190805_00012.jpg

Looking at the outlet of the structure. (2019)

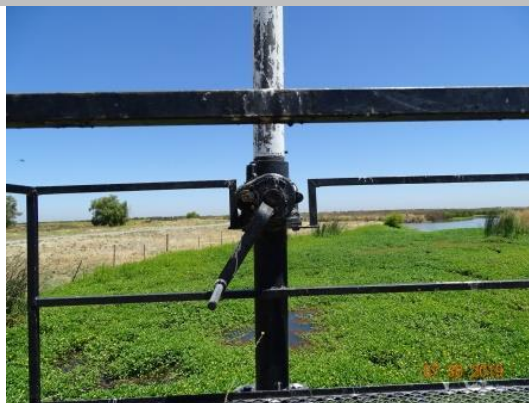
Photo 1 of 2 : ST_2019_NA0010_50_14_20190805_00014.jpg

LM Start	0.00	Rating **	A	Issue No.	14
LM End	0.00	Issue Type +	Ma	Location *	
Category	Structures & Concrete Lined Channels			GPS Latitude/Longitude	
				Start	End
Item	Manual Gate Operators			37.205787 °	37.205787 °
				-120.696838 °	-120.696838 °
DWR ID	DWR_NA0010_50_t_2012_14				
Action/Comments					
Inspector Comments: Manual gates were in good working condition.

Typical view of manual gate control. (2019)

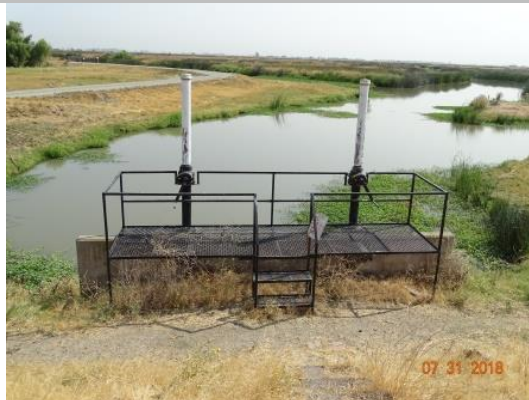
Photo 2 of 2 : ST_2019_NA0010_50_14_20190613_00006.jpg

View of the manual gate controls. (2018)

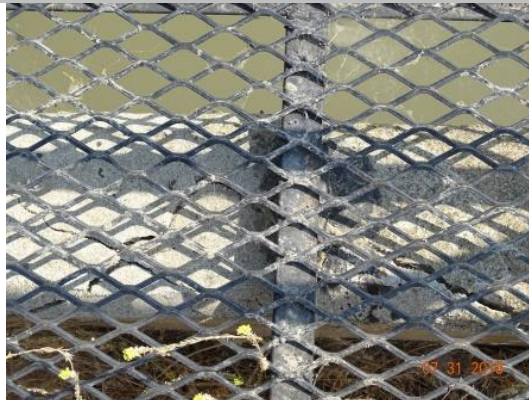
Photo 1 of 3 : ST_2019_NA0010_50_15_20190613_00007.jpg

LM Start	0.00	Rating **	A	Issue No.	15
LM End	0.00	Issue Type +	Ma	Location *	
Category	Structures & Concrete Lined Channels			GPS Latitude/Longitude	
				Start	End
Item	Concrete Surfaces			37.205787 °	37.205787 °
				-120.696838 °	-120.696838 °
DWR ID	DWR_NA0010_50_t_2012_15				
Action/Comments					
Inspector Comments: Small crack was found on headwall, but the structure is not threatened.

Small cracking on the headwall. (2018)

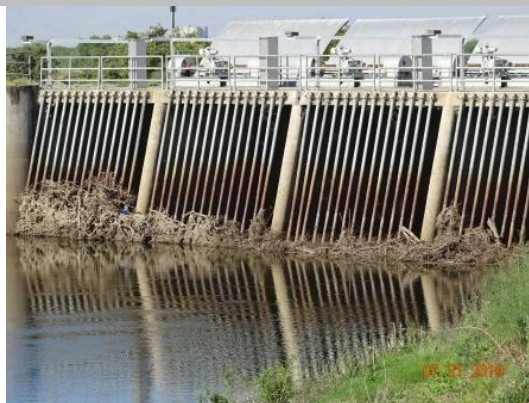
Photo 1 of 1 : ST_2019_NA0010_64_2_20190806_00012.jpg

LM Start	0.00	Rating **	M	Issue No.	2
LM End	0.00	Issue Type +	Ma	Location *	
Category	Structures & Concrete Lined Channels	GPS Latitude/Longitude			
		Start		End	
Item	Vegetation & Obstructions	36.773292 °		36.773292 °	
		-120.285206 °		-120.285206 °	
DWR ID	DWR_NA0010_64_t_2017_2				
Action/Comments					
Inspector Comments: Vegetation debris located on the inlet side of the structure at the trash racks needs to be removed.

Debris caught on trash racks of the structure. (2019)

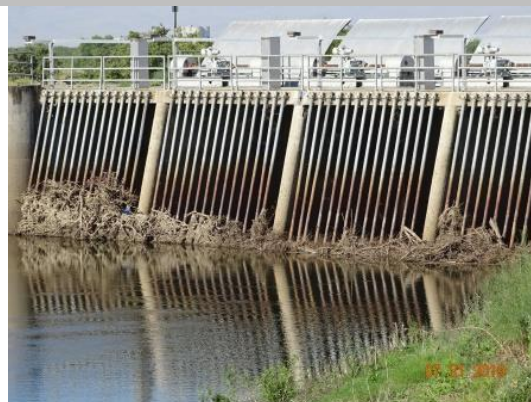
Photo 1 of 1 : ST_2019_NA0010_64_10_20190806_00013.jpg

LM Start	0.00	Rating **	A	Issue No.	10
LM End	0.00	Issue Type +	Ma	Location *	
Category	Structures & Concrete Lined Channels	GPS Latitude/Longitude			
		Start		End	
Item	Trash Racks	36.773292 °		36.773292 °	
		-120.285206 °		-120.285206 °	
DWR ID	DWR_NA0010_64_t_2017_10				
Action/Comments					
Inspector Comments: Trash racks appear to be in good condition.

View of trash racks. (2019)

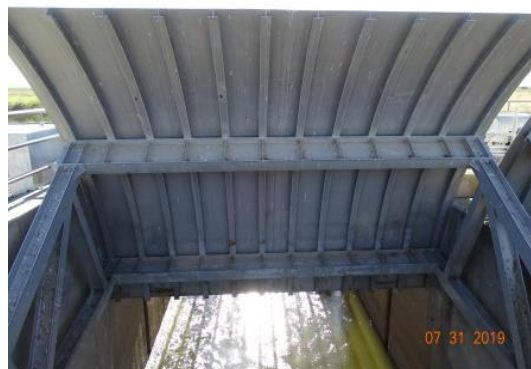
Photo 1 of 2 : ST_2019_NA0010_64_12_20190806_00014.jpg

LM Start	0.00	Rating **	A	Issue No.	12
LM End	0.00	Issue Type +	Ma	Location *	
Category	Structures & Concrete Lined Channels	GPS Latitude/Longitude			
		Start		End	
Item	Sluice/Slide Gates	36.773292 °		36.773292 °	
		-120.285206 °		-120.285206 °	
DWR ID	DWR_NA0010_64_t_2017_12				
Action/Comments					
Inspector Comments: Gates are in good working condition.

Typical view of gates. (2019)

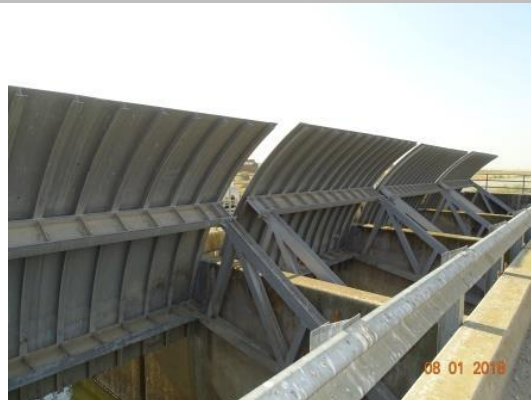
Photo 2 of 2 : ST_2019_NA0010_64_12_20190613_00006.jpg

View of the gates. (2018)

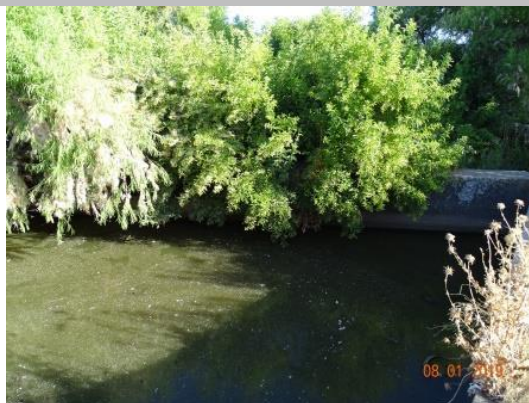
Photo 1 of 1 : ST_2019_NA0010_66_2_20190808_00022.jpg

LM Start	0.00	Rating **	M	Issue No.	2
LM End	0.00	Issue Type +	Ma	Location *	
Category	Structures & Concrete Lined Channels	GPS Latitude/Longitude			
		Start		End	
Item	Vegetation & Obstructions	37.112360 °		37.112360 °	
		-120.589598 °		-120.589598 °	
DWR ID	DWR_NA0010_66_t_2017_2				
Action/Comments					
Inspector Comments: Vegetation growing at the downstream side of structure.

Trees growing over the downstream side of the structure. (2019)

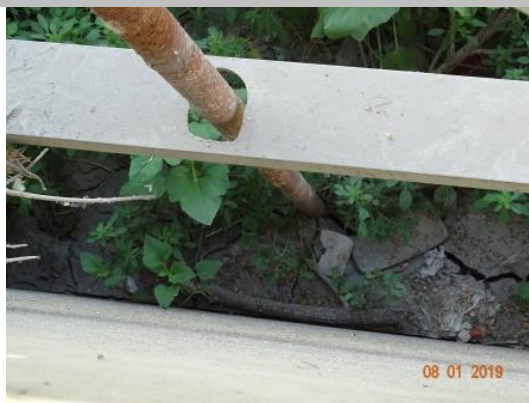
Photo 1 of 1 : ST_2019_NA0010_66_3_20190808_00024.jpg

LM Start	0.00	Rating **	U	Issue No.	3
LM End	0.00	Issue Type +	Ma	Location *	
Category	Structures & Concrete Lined Channels	GPS Latitude/Longitude			
		Start		End	
Item	Shoaling / Sedimentation	37.112360 °		37.112360 °	
		-120.589598 °		-120.589598 °	
DWR ID	DWR_NA0010_66_t_2017_3				
Action/Comments					
Inspector Comments: Sedimentation blocking inlet and function of slide gates.

Inlet gates buried under sedimentation. (2019)

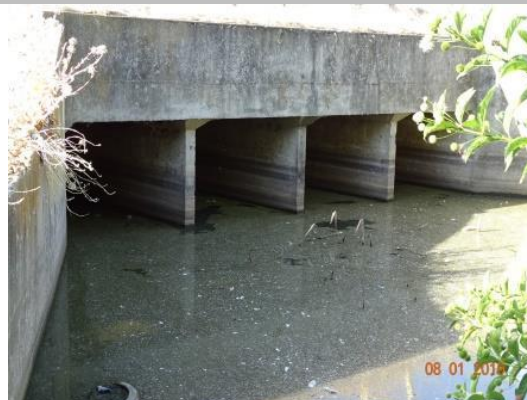
Photo 1 of 2 : ST_2019_NA0010_66_7_20190808_00027.jpg

LM Start	0.00	Rating **	A	Issue No.	7
LM End	0.00	Issue Type +	Ma	Location *	
Category	Structures & Concrete Lined Channels			GPS Latitude/Longitude	
				Start	End
Item	Culverts: Inlets / Outlets			37.112360 °	37.112360 °
				-120.589598 °	-120.589598 °
DWR ID	DWR_NA0010_66_t_2017_7				
Action/Comments					
Inspector Comments: Culverts are in good condition but there is sedimentation built up above the inlets/slide gates see issue 3.

View of culvert outlet. (2019)

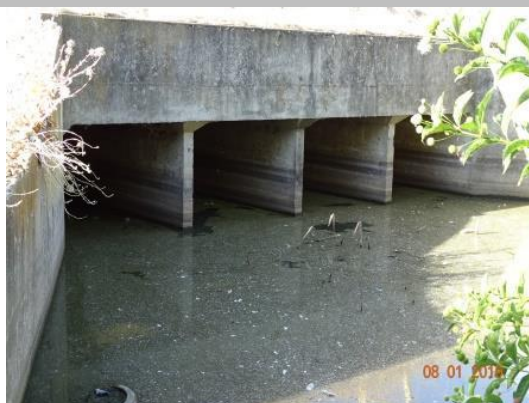
Photo 1 of 1 : ST_2019_NA0010_66_8_20190808_00025.jpg

LM Start	0.00	Rating **	A	Issue No.	8
LM End	0.00	Issue Type +	Ma	Location *	
Category	Structures & Concrete Lined Channels			GPS Latitude/Longitude	
				Start	End
Item	Culverts: Breaks / Holes / Cracks			37.112360 °	37.112360 °
				-120.589598 °	-120.589598 °
DWR ID	DWR_NA0010_66_t_2017_8				
Action/Comments					
Inspector Comments: No visible issus identified for the culverts.

View of culvert outlets. (2019)

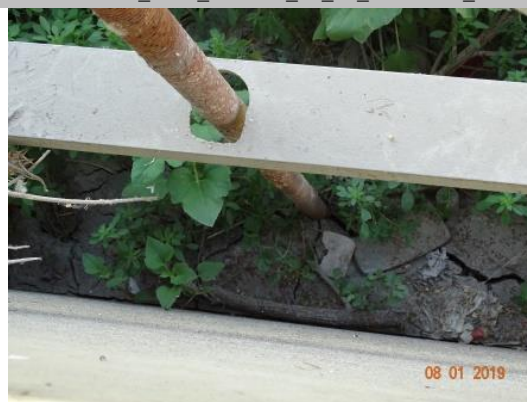
Photo 1 of 2 : ST_2019_NA0010_66_12_20190808_00028.jpg

LM Start	0.00	Rating **	M	Issue No.	12
LM End	0.00	Issue Type +	Ma	Location *	
Category	Structures & Concrete Lined Channels	GPS Latitude/Longitude			
		Start		End	
Item	Sluice/Slide Gates	37.112360 °		37.112360 °	
		-120.589598 °		-120.589598 °	
DWR ID	DWR_NA0010_66_t_2017_12				
Action/Comments					
Inspector Comments: Sedimentation on the inlet side of the structure impacts the function of slide gates.

View of slide gate with sedimentation. (2019)

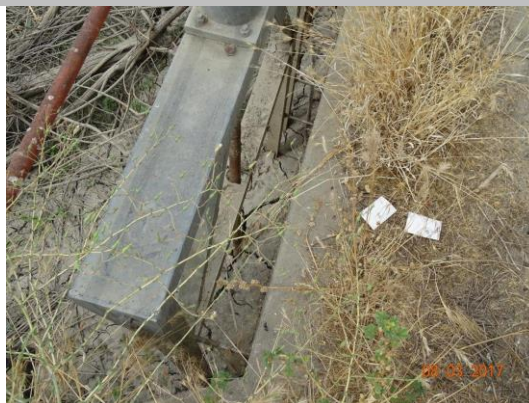
Photo 2 of 2 : ST_2019_NA0010_66_12_20190613_00014.jpg

LM Start	0.00	Rating **	M	Issue No.	12 (cont)	
LM End	0.00	Issue Type +	Ma	Location *		
Category	Structures & Concrete Lined Channels			GPS Latitude/Longitude		
				Start		End
Item	Sluice/Slide Gates			37.112360 °		37.112360 °
				-120.589598 °		-120.589598 °
DWR ID	DWR_NA0010_66_t_2017_12					
Action/Comments						
Inspector Comments: Sedimentation on the inlet side of the structure impacts the function of slide gates.

View of slide gate with sedimentation. (2017)

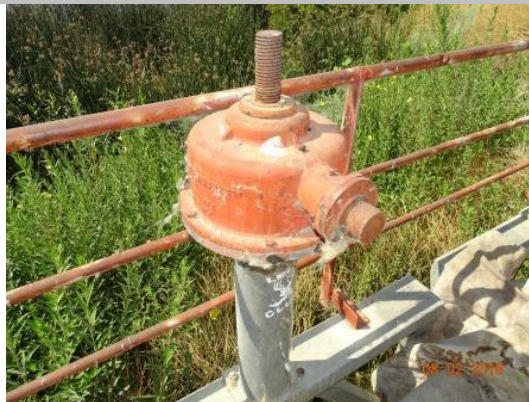
Photo 1 of 1 : ST_2019_NA0010_66_14_20190613_00015.jpg

LM Start	0.00	Rating **	A	Issue No.	14
LM End	0.00	Issue Type +	Ma	Location *	
Category	Structures & Concrete Lined Channels			GPS Latitude/Longitude	
				Start	End
Item	Manual Gate Operators			37.112360 °	37.112360 °
				-120.589598 °	-120.589598 °
DWR ID	DWR_NA0010_66_t_2017_14				
Action/Comments					
Inspector Comments: All manual gates operators appear to be in proper working condition. District caps off manual operation stem to secure gates.

Typical view of the manual gate operators. (2018)

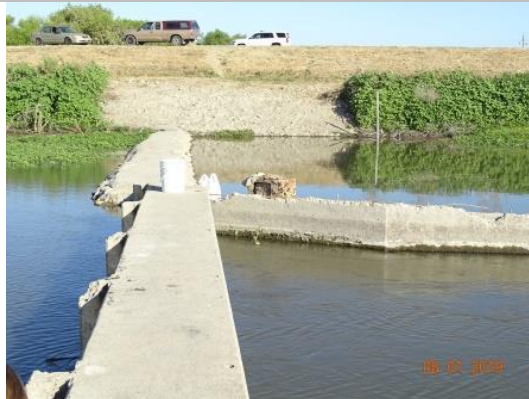
Photo 1 of 2 : ST_2019_NA0010_67_1_20190808_00008.jpg

View across structure from right bank. (2019)

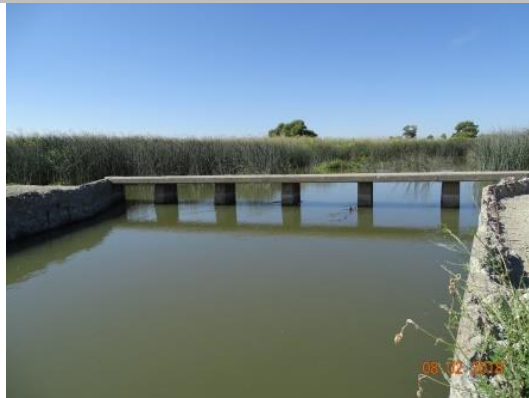
Photo 2 of 2 : ST_2019_NA0010_67_1_20190613_00001.jpg

Overview of structure looking upstream. (2018)

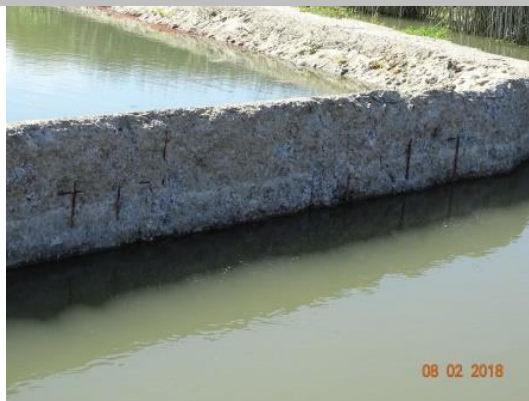
Photo 2 of 3 : ST_2019_NA0010_67_15_20190613_00007.jpg

Exposed rebar along Parshall flume wall. (2018)

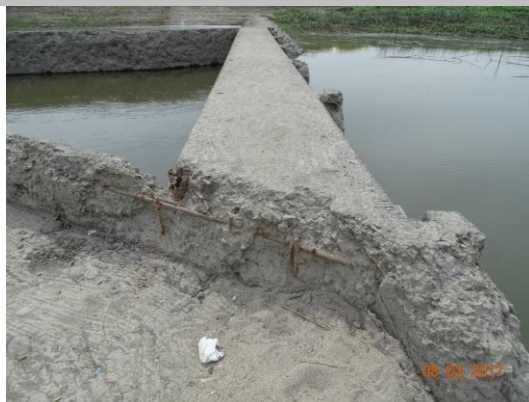
Photo 3 of 3 : ST_2019_NA0010_67_15_20190613_00003.jpg

Looking east at the left wall of the structure with exposed rebar. (2017)
